**HYDRAULIC MODEL  
INVESTIGATION**

AD-A134 641  
**Placer Creek High-Velocity Channel  
and Debris Basin at Wallace, Idaho**

**SPONSORED BY  
U. S. ARMY CORPS OF ENGINEERS  
SEATTLE DISTRICT**

**CONDUCTED BY  
DIVISION HYDRAULIC LABORATORY  
U. S. ARMY CORPS OF ENGINEERS  
NORTH PACIFIC DIVISION  
BONNEVILLE, OREGON**

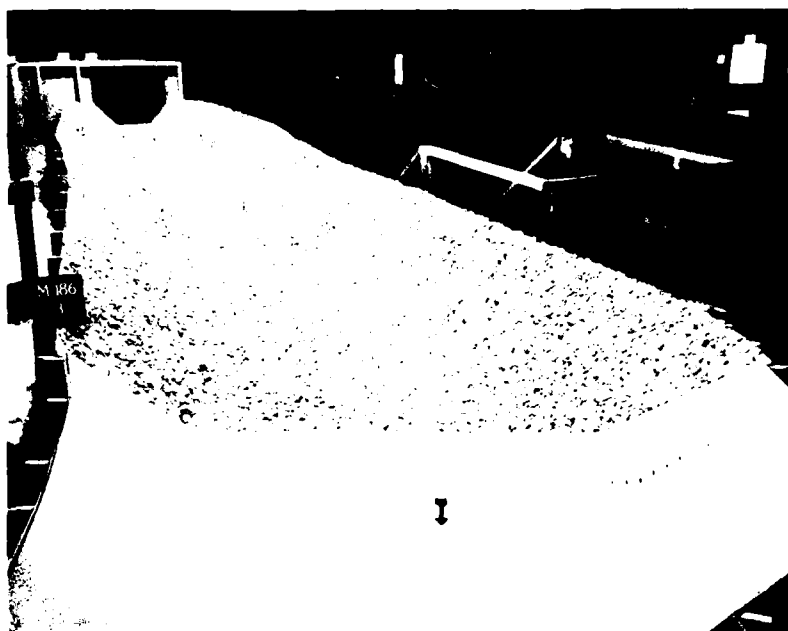
Photograph 1. Trash barriers and riprapped channel

12. Details of the original design are shown on plate 2. The debris basin consisted of a trapezoidal channel with improved bank protected by riprap with two debris barriers (plate 2 and photograph 1). Tests were conducted with discharges of 2,400 cfs, 3,300 cfs, and 4,600 cfs (design flow). Photograph 2 shows the design flow condition through the debris basin. The debris basin was ineffective, as all three discharges passed through the basin as a narrow, high-velocity stream with eddies on both sides of the basin between the debris barriers. At 4,600 cfs, impact on the upstream debris barrier was localized in the center where flow ride-up on the vertical beams overtopped the barriers (photograph 3). The entire downstream barrier was submerged, and the wall near station 40+00 (upstream of "V" bottom channel) was occasionally overtopped by the concentration of flow on the left bank (photograph 4).

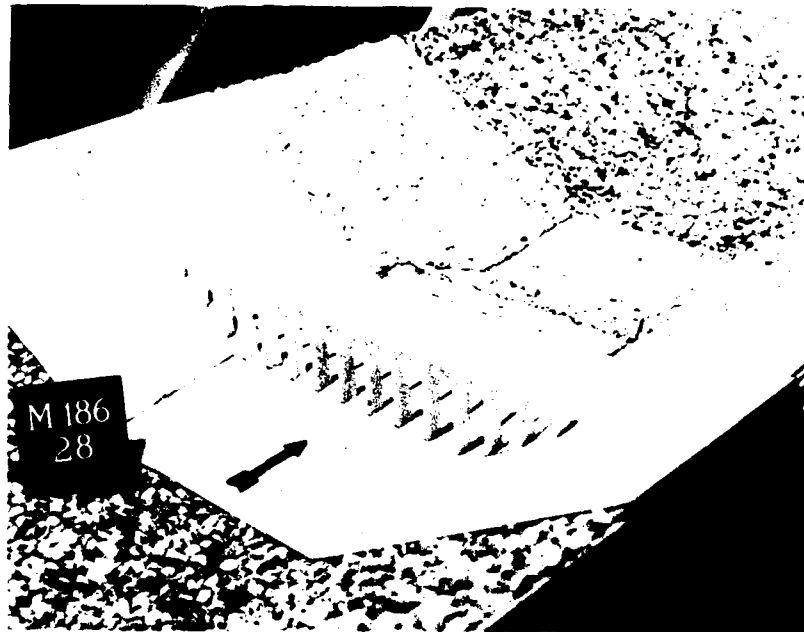
Photograph 5. Dry bed

Photograph 6. Discharge 4,600 cfs

Plan A Upstream Trash Barrier

13. Several alternate modifications to the original design were devised and tested to alleviate the unacceptable hydraulic conditions which existed in the basin and at the upstream debris barrier. The Plan A design had a barrier consisting of fewer vertical beams in the upstream debris barrier (photograph 5) but resulted in conditions similar to the original design (photograph 6). The Plan B design had a barrier consisting of sloping braces on the upstream face of the barrier (photograph 7). The purpose of these braces was to streamline the beams and divide the flow to provide a major reduction in upwelling downstream from the barrier (photograph 8). Various schemes were tested in an attempt to reduce the high-velocity flow passing through the basin and uniformly distribute flow into the basin; however, no schemes were successful, and a complete redesign of the basin was considered a necessity.

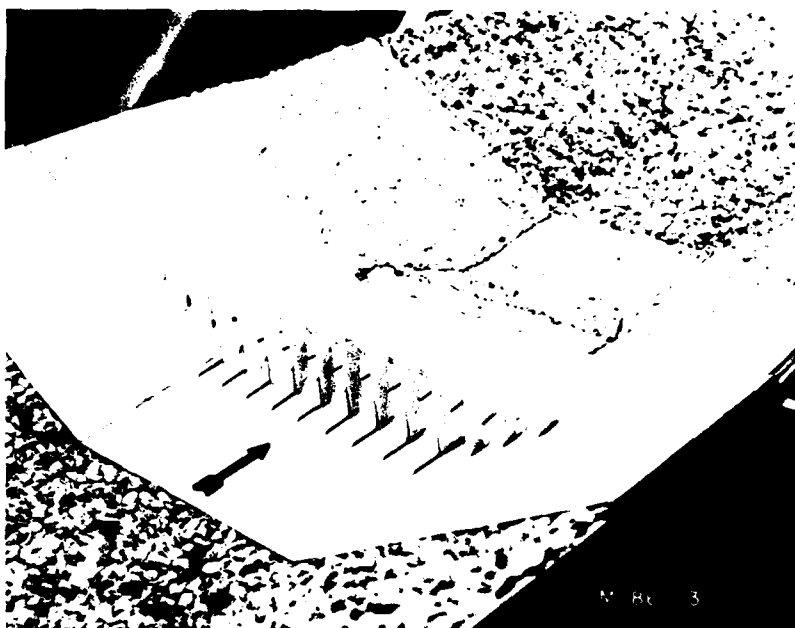
Photograph 7. Dry bed

Photograph 8. Discharge 4,600 cfs

Plan B Upstream Trash Barrier

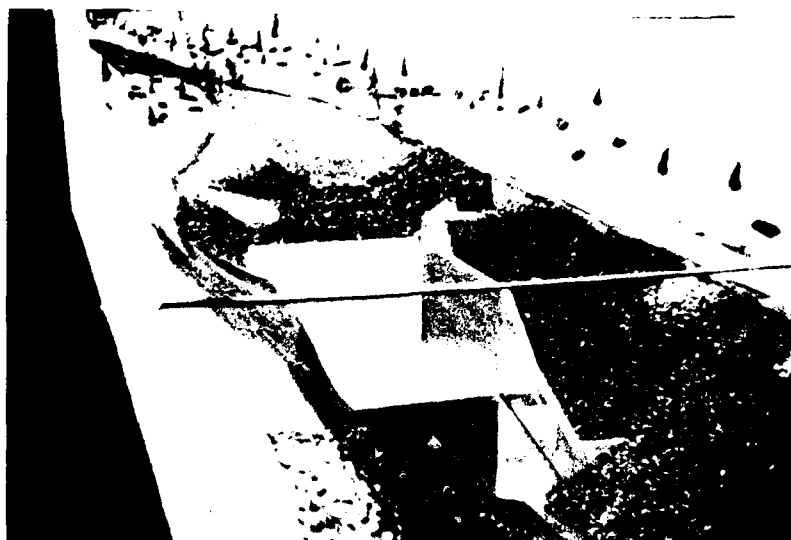
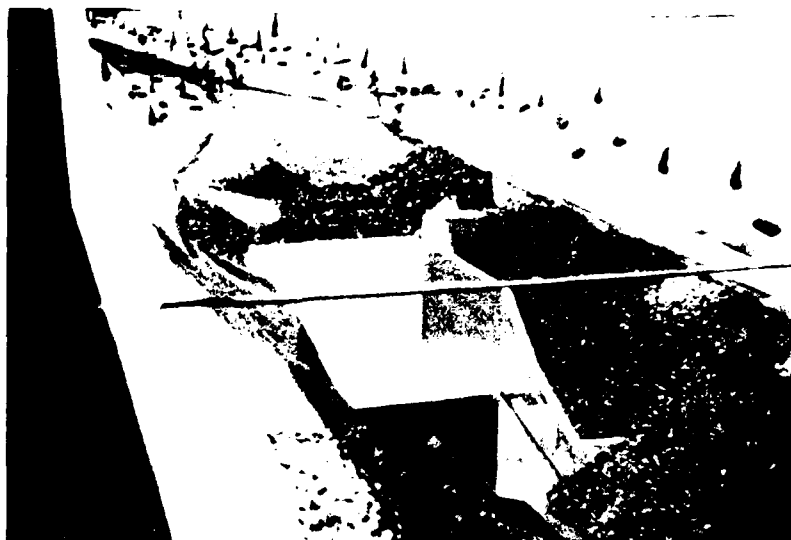
Photograph 9. Looking upstream at drop structure

Plan C Debris Basin and Drop Structure

14. The Plan C basin consisted of a deeper, shorter basin with a 23-foot-high drop structure at the upstream end (photograph 9) with a vertical training wall on the left bank and a single debris barrier at the downstream end near the channel entrance (photograph 10). The drop structure was provided to dissipate the energy of the incoming flow and to allow debris and bed material to settle out within the debris basin. Velocities in the Plan C basin, listed in table B, indicated that acceptable hydraulic conditions would be achieved using this scheme.

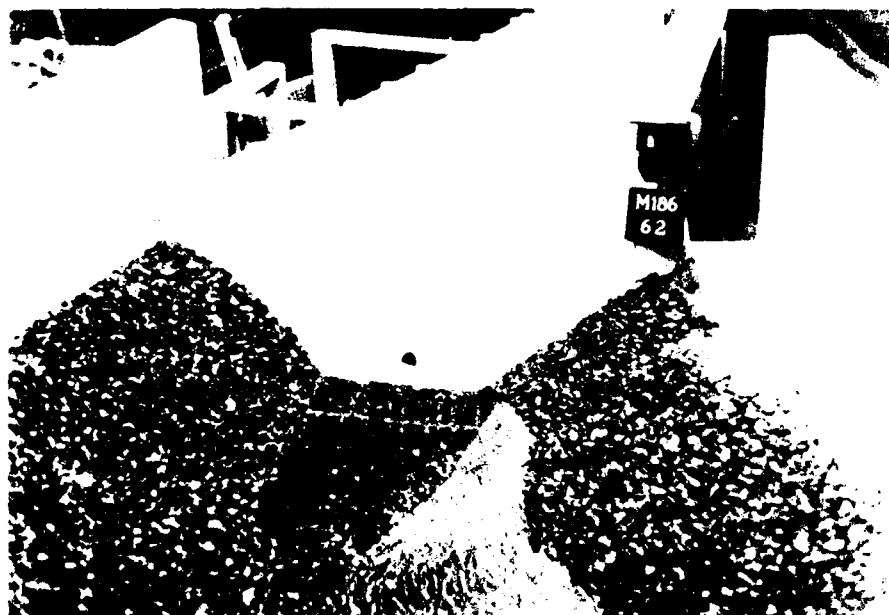
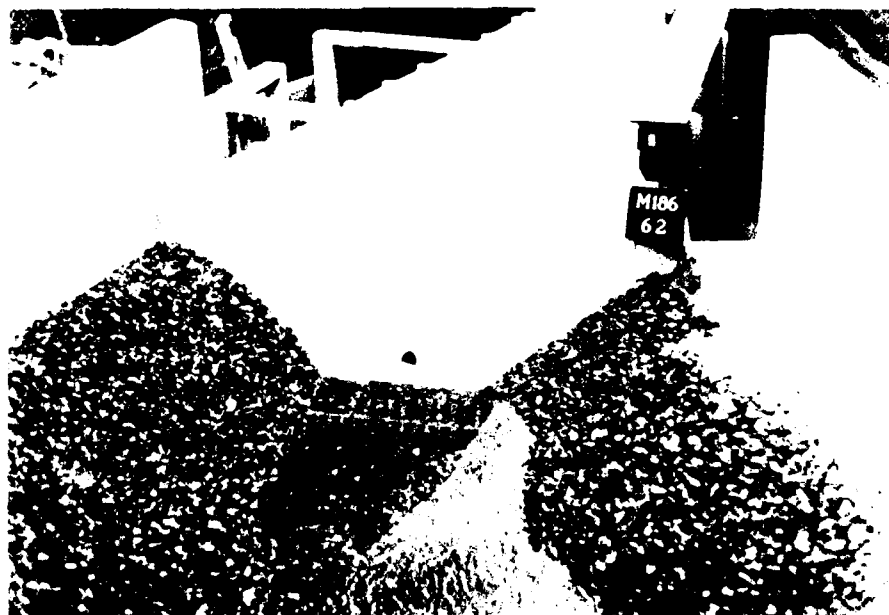
Photograph 10. Upstream view of trash barrier

Plan C Debris Basin and Drop Structure

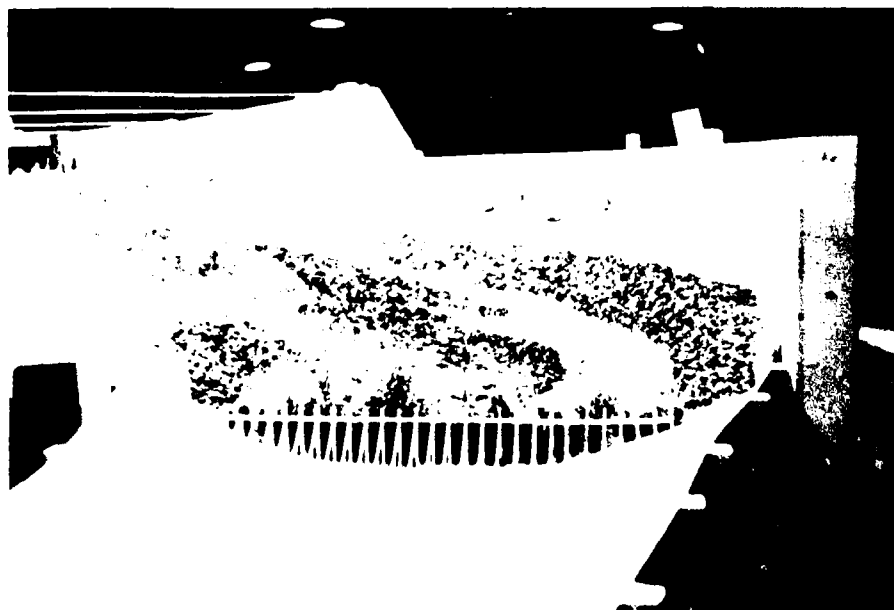
Photograph 21. 4th hour; discharge 1,497 cfs

Photograph 22. After 4½ hours; discharge 1,073 cfs

Final-Design Debris Basin  
200-Year Thunderstorm Flood Hydrograph

Creek channel. Initial fallout in the basin occurred between stations 42+50 and 43+00. As the velocities and volume of bed material increased, the deposition moved downstream. After the peak had passed, the material still moving was depositing more in the area of stations 43+00 to 44+00. Eventually the bed material filled the debris basin from bank to bank and from the drop structure to the trash barrier by slow continuous movement of material downstream. Trash formed a porous barrier on the racks, and bed material was deposited against it. Rock stopped moving at approximately 700 cfs. At the end of the flood, the top of the drop structure was under 4.2 feet of debris and the material had backed upstream as far as station 45+20. Velocities along the riprapped banks of the basin during the flood were 12 to 14 fps on the left bank and 17 fps on the right bank. Photographs 19 to 27 show the sequence of the test. A centerline profile of the deposited material is listed in table D.

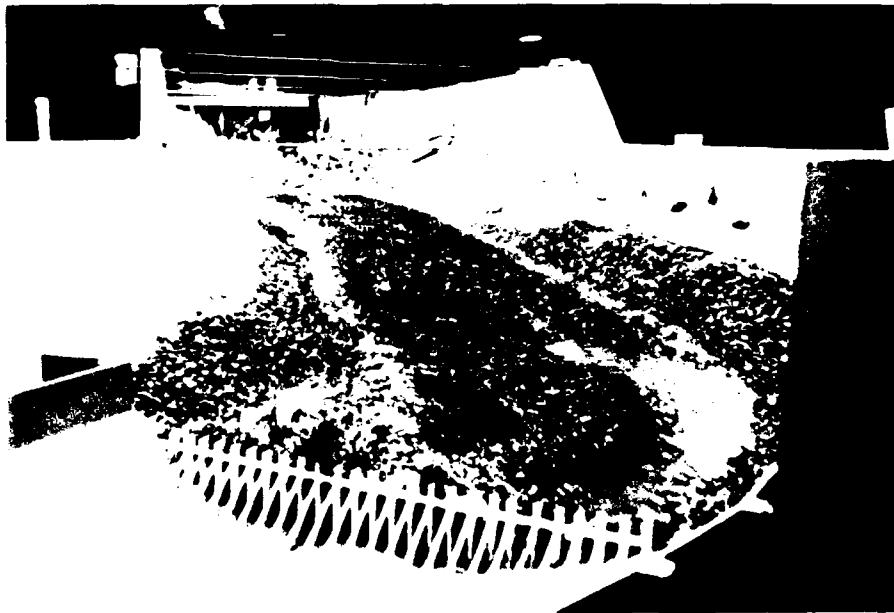
Photograph 23. 200-year thunderstorm flood hydrograph  
5th hour; discharge 722 cfs

Final-Design Debris Basin

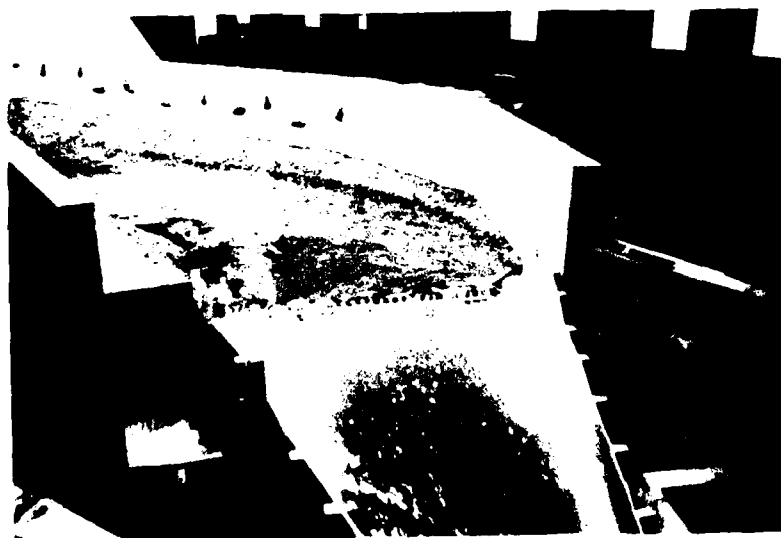
Photograph 28. Drop structure and debris basin

Photograph 29. Trash barrier

Final-Design Debris Basin  
 200-Year Winter Rainflood Hydrograph  
 1st Hour; Discharge 750 cfs

21. A longer, 120-hour winter-rain flood hydrograph was also tested in the same manner. This flood had a maximum discharge of 3,050 cfs during the 28th hour (see table C). The test was begun at the 23rd hour with a discharge of 565 cfs and concluded after the 49th hour with a discharge of 760 cfs. The early difference between the two tests was that the bed material buildup started much farther upstream with the winter storm than with the thunderstorm flood. Initial fallout occurred just 40 feet downstream from the drop structures. Additional deposition of material was observed in downstream reaches. Flow was uniform across the top of the drop structure, but most of the bed material shifted towards the right bank. At a flow of 2,500 cfs (26-1/2 hours), rock had moved down to station 42+50 and the majority of rock was deposited on the right side. Maximum velocities along the left bank were 12 to 15 fps. The left end of the trash barrier was just starting to overtop. At the peak discharge of 3,050 cfs, rock had moved downstream to station 42+25 and had formed an exposed bar on the right side. Maximum velocities along the left bank had reduced to 10 to 12 fps. As the flow receded, bed material built up closer to the drop structure, and flow changed from

plunging to skimming which drew more rock in against the drop structure. At 1,700 cfs, rock had covered the top of the drop structure and was evenly distributed from bank to bank down to station 41+25. As the flow receded further, channels were cut through on one side and then the other and would change as the bed material slowly built up. At the end of the test, 5.1 feet of rock covered the top of the drop structure. A total of 17,600 cu yd had been deposited in the debris basin. Photographs 28 to 38 show the hydrograph sequence. A top-of-rock profile at the conclusion of the test is listed in table D.

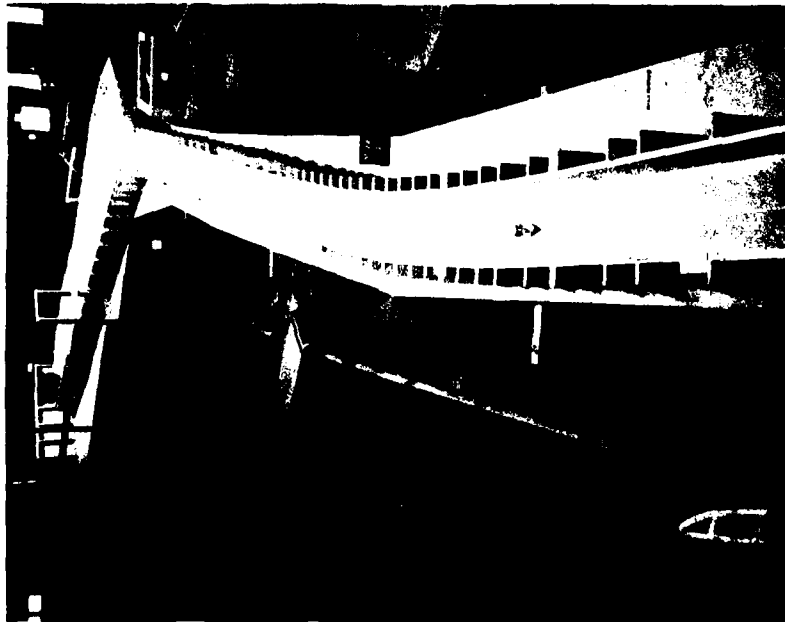
Photograph 39. Overall view of upstream section of model with original-design debris basin

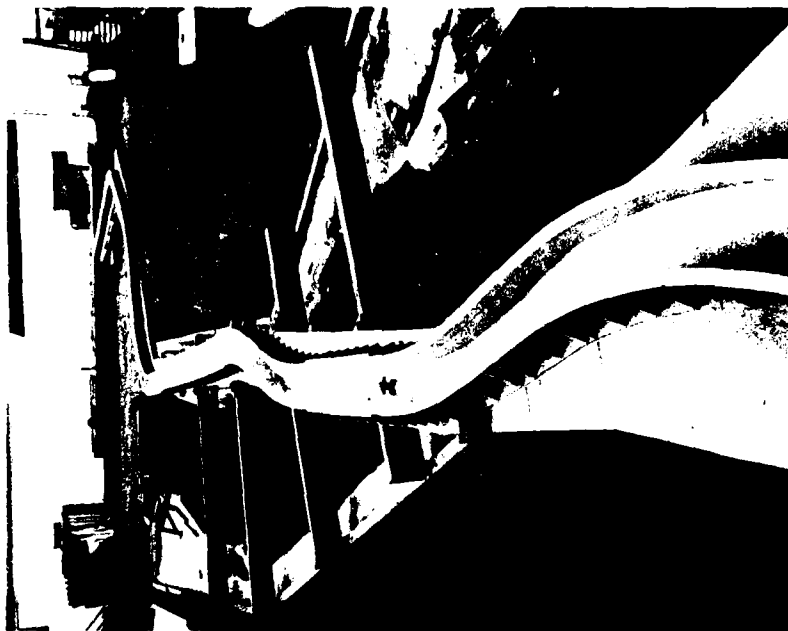
Photograph 40. Overall view of downstream section of model

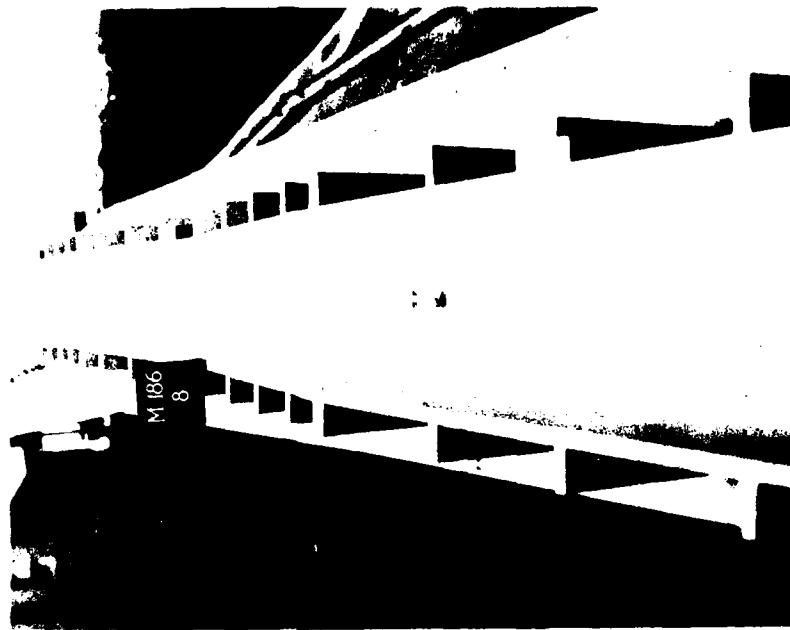
Photograph 42. Transition from 20-foot-wide to  
17-foot-wide channel; Station  
36+16 to 36+55

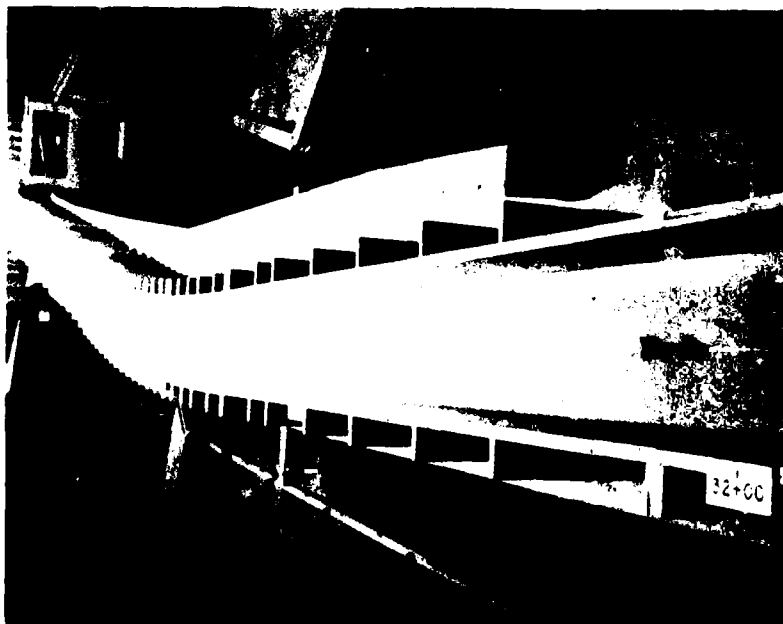
Photograph 43. Section of V-bottom channel downstream from Curve No. 12 near Station 33+00

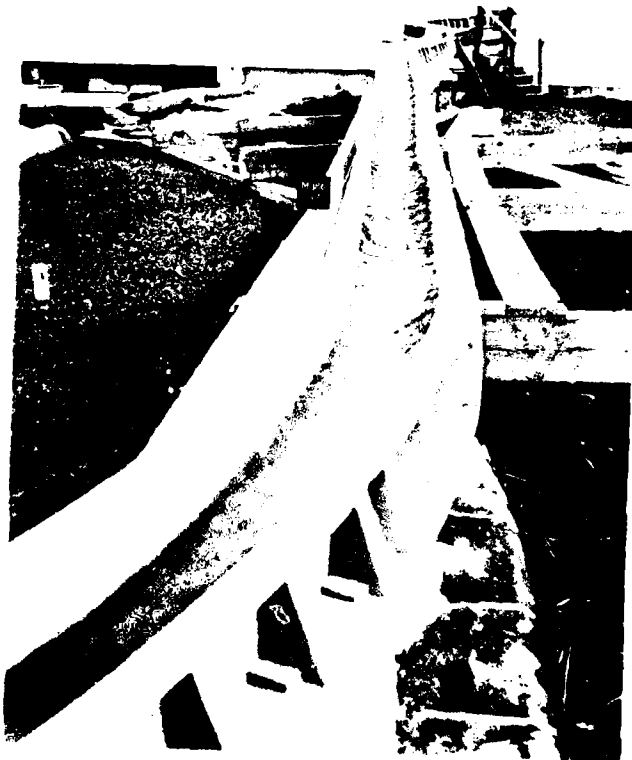
Photograph 45. Looking upstream from Curve No. 3  
(Station 15+00) at standing waves  
created by Curves No. 4 and 5;  
discharge 4,600 cfs

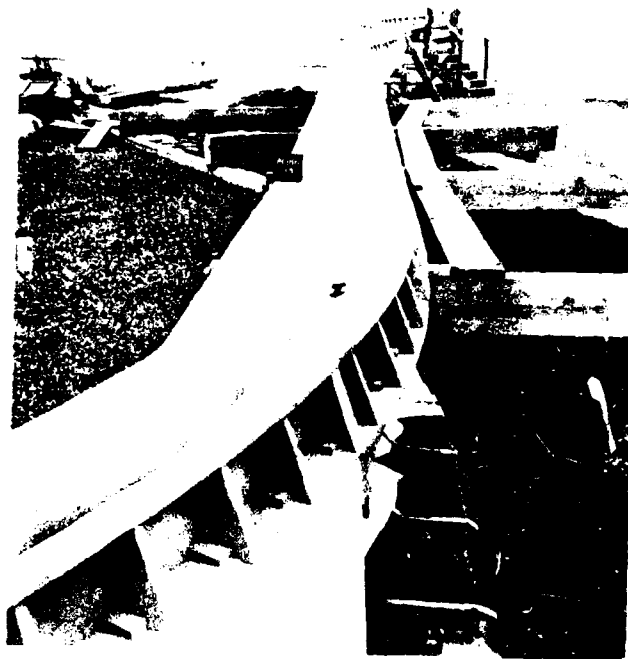
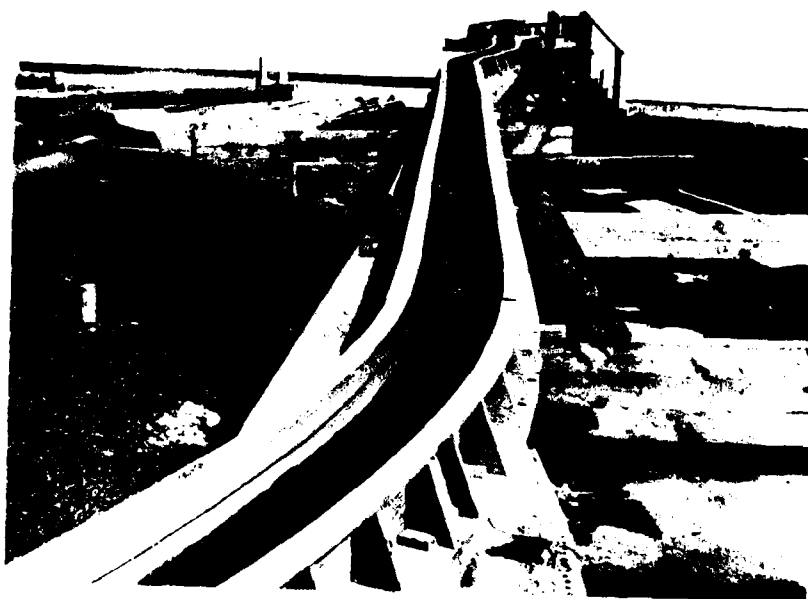
Photograph 46. Dry bed

Photograph 47. Discharge 4,600 cfs

Looking Upstream From Curve No. 3  
After Removal of Curves No. 4 and 5

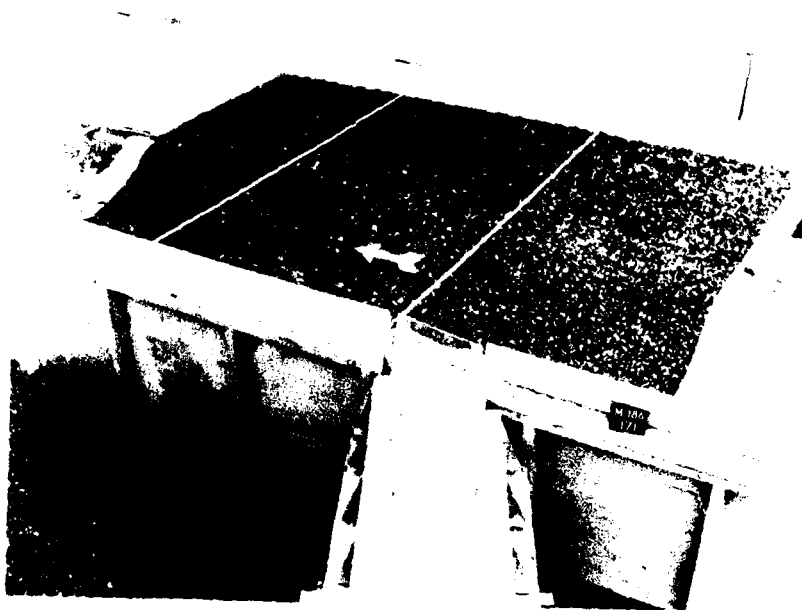
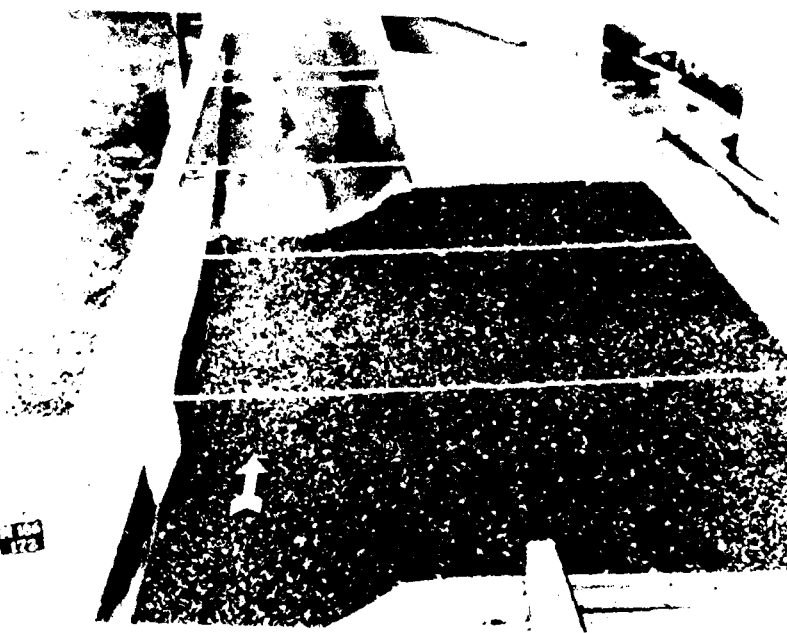
Photograph 49. View from Placer Creek

Photograph 50. View from South Fork Coeur d'Alene River

Movable-Bed Original Conditions  
in South Fork Coeur d'Alene River

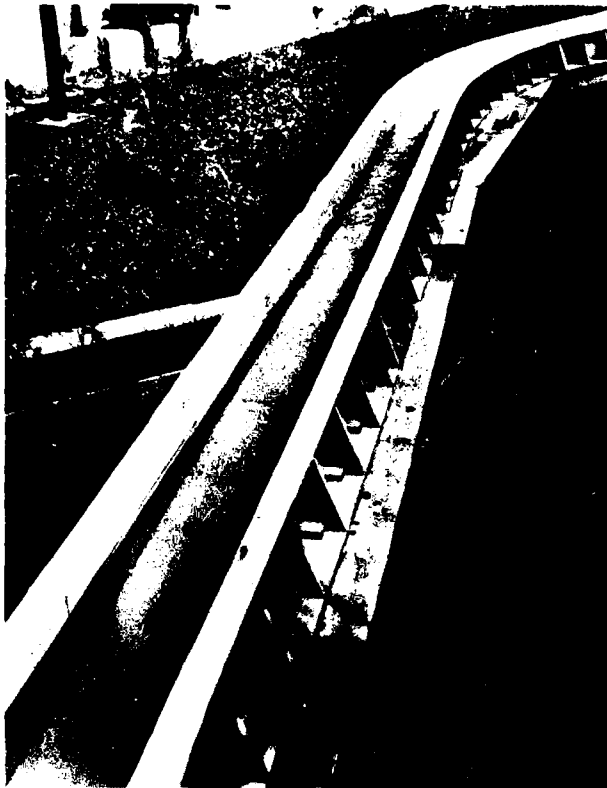
Photograph 51. Hydraulic jump at Station 7+00;  
Placer Creek discharge 565 cfs

and pushed the hydraulic jump downstream another 150 feet. Walls were still overtopped at the upstream end of the culvert. No movement of bed material in the South Fork Coeur d'Alene River was observed. At the 28th hour when the flood peaked, the existing small scour hole in the river at the exit of Placer Creek was enlarged. The high flow in the river moved the scoured material downstream. An upwelling along the left bank wall deposited some of the smaller rock on top of the wall. The jump in Placer Creek was only 50 feet upstream from the highway culvert and caused a high impact on the culvert and significant overtopping of the walls (photographs 51 to 55).

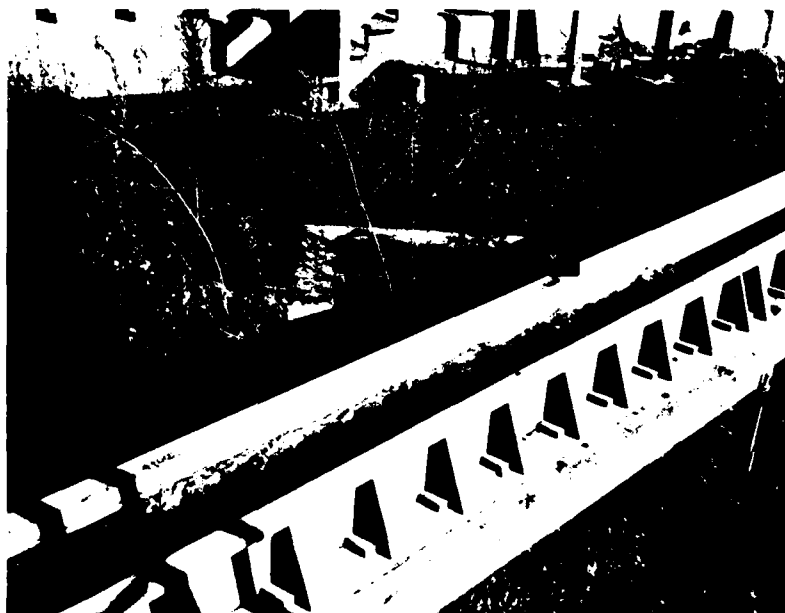
Photograph 52. Hydraulic jump at Station 5+50;  
Placer Creek discharge 1,175 cfs

Winter Rainflood Hydrograph

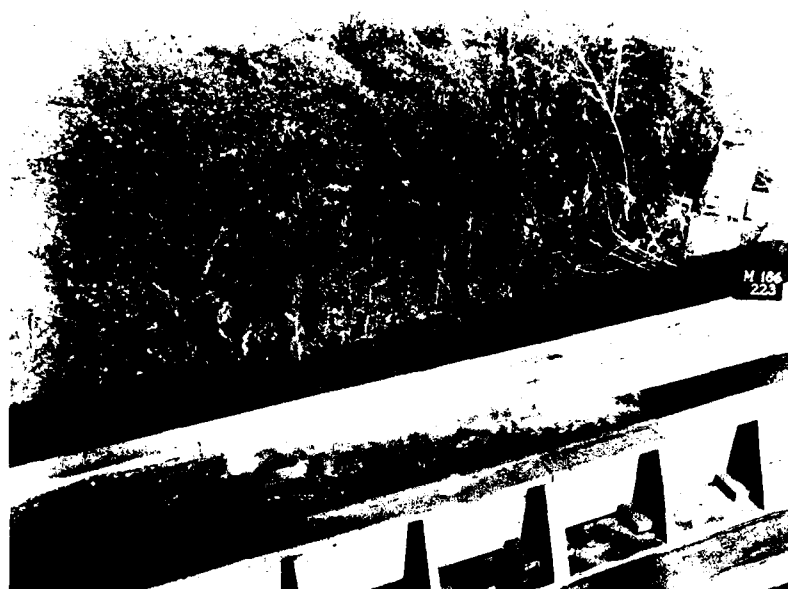
Photograph 53. Hydraulic jump at Station 4+00;  
Placer Creek discharge 2,000 cfs

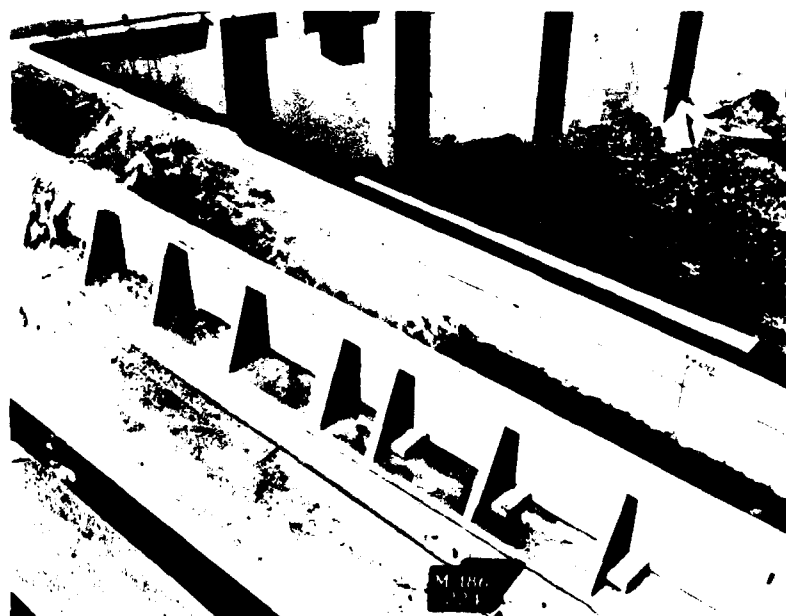
Photograph 54. Hydraulic jump at Station 2+50;  
Placer Creek discharge 3,050 cfs

Winter Rainflood Hydrograph

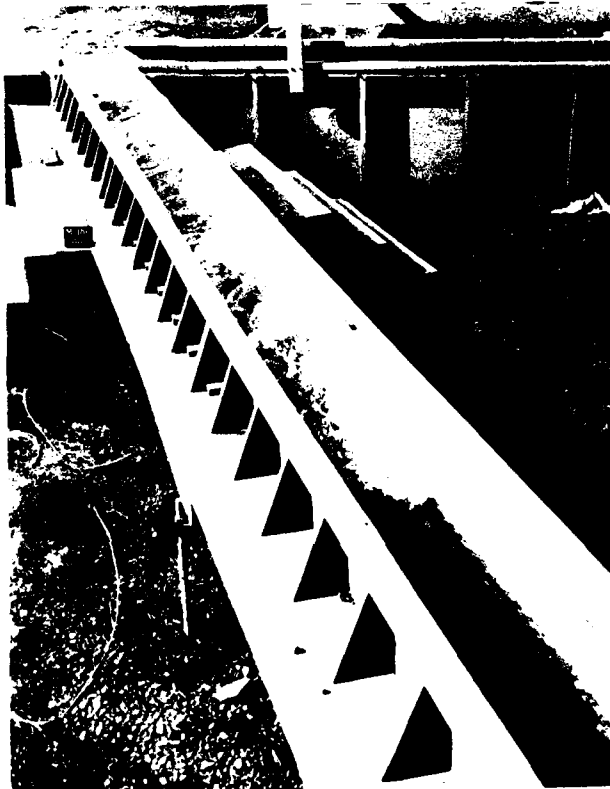
Photograph 55. Hydraulic jump at Station 3+75;  
Placer Creek discharge 2,000 cfs

Winter Rainflood Hydrograph

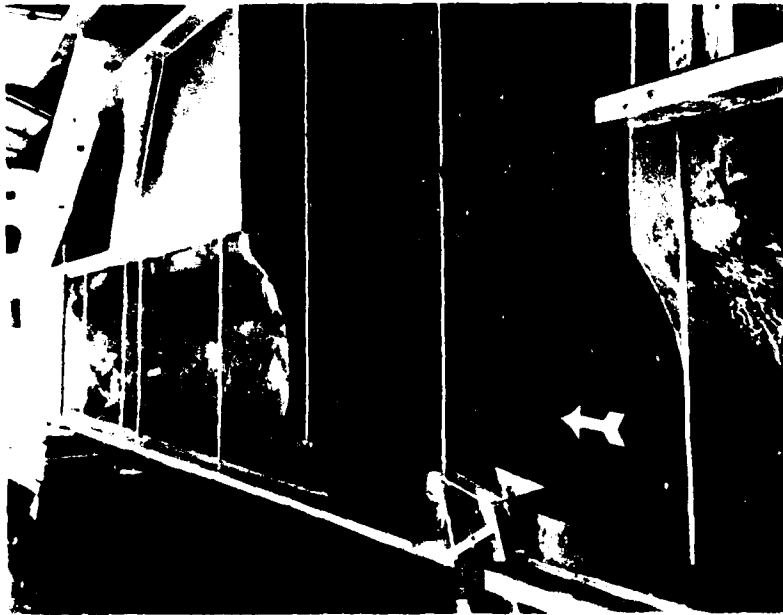
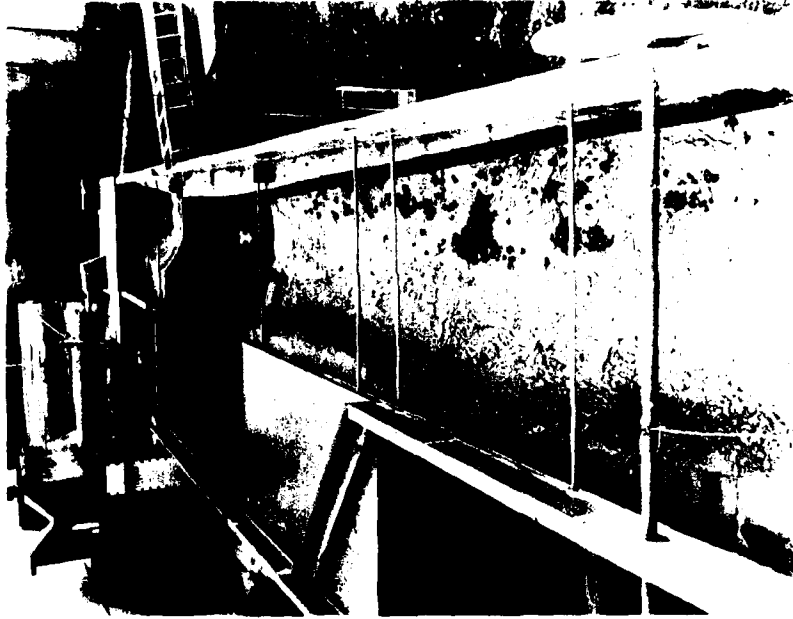
Photograph 56. View from South Fork Coeur d'Alene River looking downstream

Winter Rainflood Hydrograph  
Eroded Condition at End of Flood

Photograph 57. View from South Fork Coeur d'Alene River looking upstream

30. As the flow reduced to 2,000 cfs in the 30th hour, the movement of bed material ceased. The jump in Placer Creek moved upstream 100 feet, and the extreme conditions at the culvert entrance were reduced. The erosion and final deposition of the scoured material are shown in photographs 56 and 57 and plate 14.

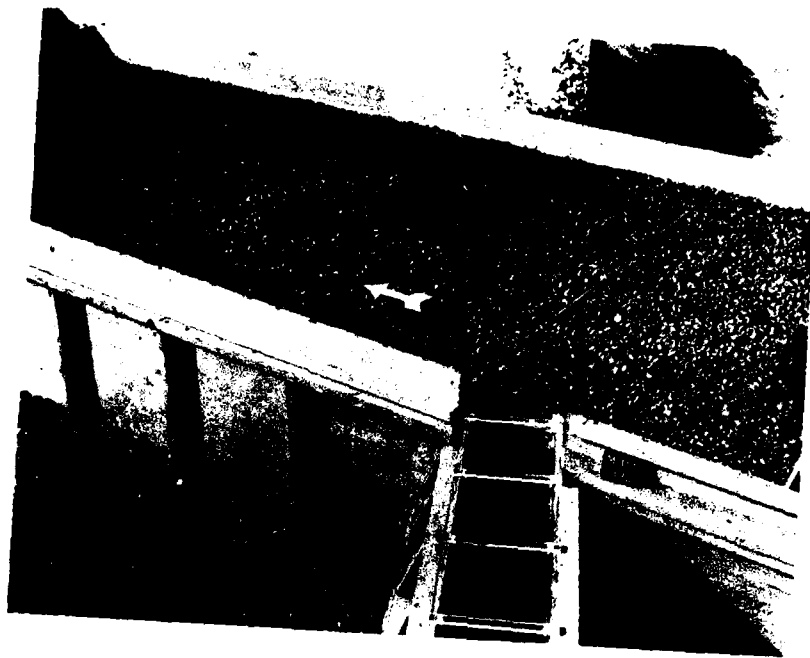
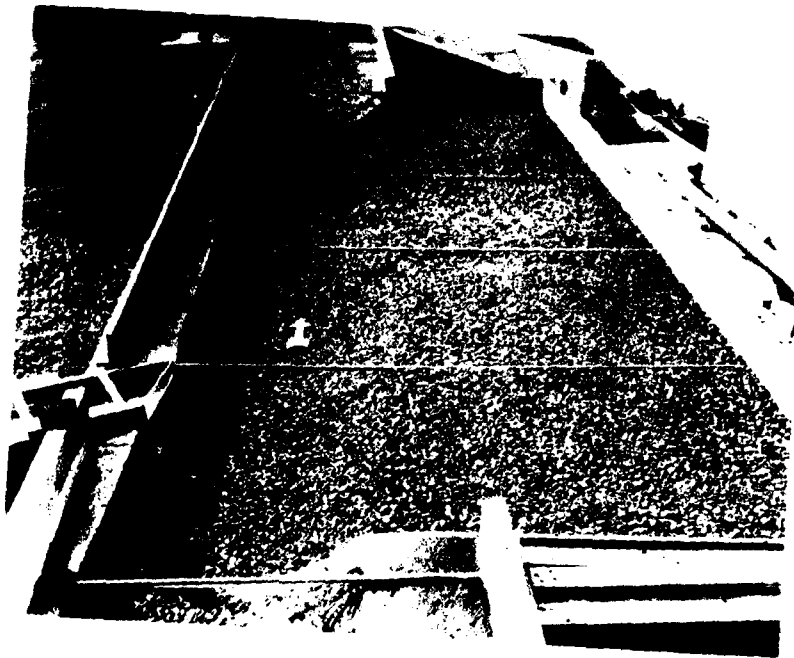
Photograph 58. View from Placer Creek

Photograph 59. View from South Fork Coeur d'Alene River

Movable-Bed Original Conditions  
in South Fork Coeur d'Alene River

31. The simulated hydrological conditions for this observation were the project design 200-year thunderstorm flood (table D). Flow in the South Fork Coeur d'Alene River was constant at 400 cfs, while flow in Placer Creek increased from 14 cfs during the 3rd hour of the storm to a maximum of 4,600 cfs shortly after the 4th hour and receded to constant at 400 cfs by the 9th hour. The movable bed section of the model reproduced 350 feet of the river invert and right bank (plate 15, photographs 58 and 59).

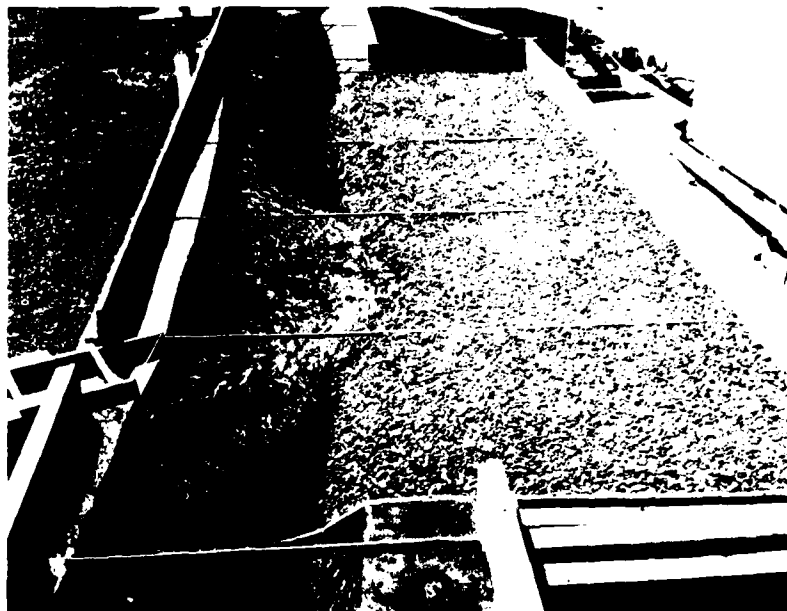
Photograph 60. View from South Fork Coeur d'Alene River

Thunderstorm Flood Hydrograph  
Placer Creek Discharge 500 cfs  
South Fork Coeur d'Alene River Discharge 400 cfs

32. The test began at the 3rd hour of the storm when Placer Creek flow was increased from 14 to 500 cfs (3 hours and 15 minutes into the storm) and quickly scoured the right bank of the South Fork Coeur d'Alene River (photograph 60). By 3 hours and 30 minutes of the storm, the flow increased to 2,350 cfs and extensive scouring was occurring. The right

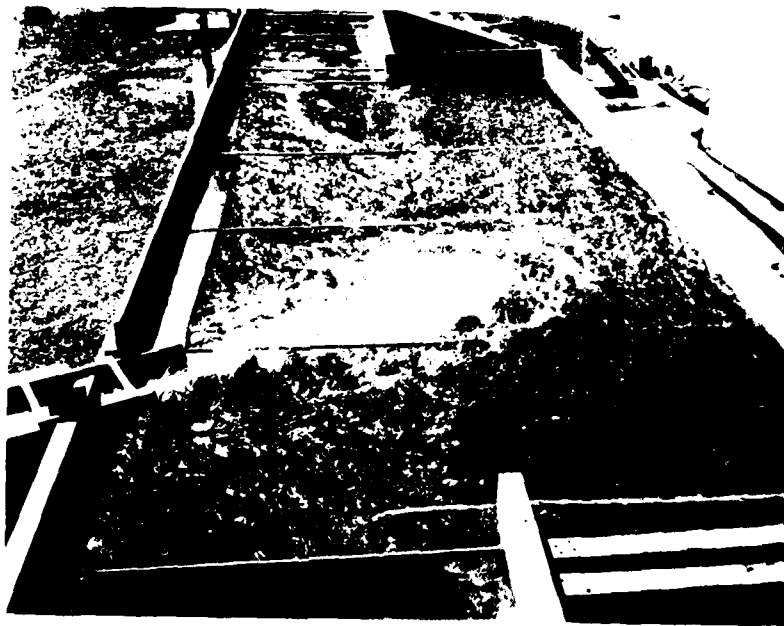
Photograph 61. View from Placer Creek

Photograph 62. View from South Fork Coeur d'Alene River

Thunderstorm Flood Hydrograph  
 Placer Creek Discharge 4,600 cfs  
 South Fork Coeur d'Alene River Discharge 400 cfs

33. The maximum flow of 4,600 cfs was reached shortly after the 4th hour of the storm (photographs 61 and 62). The volume of scouring increased with the bulk of the rock forming a berm beyond and downstream from the expanded scour area. Flow was still over the top of the South Fork Coeur d'Alene River bank. Scouring reduced sharply when flow dropped to 4,100 cfs after 4 hours and 30 minutes of the storm. The shooting flow was reduced, and the top of the newly formed berm of aggraded rock was exposed.

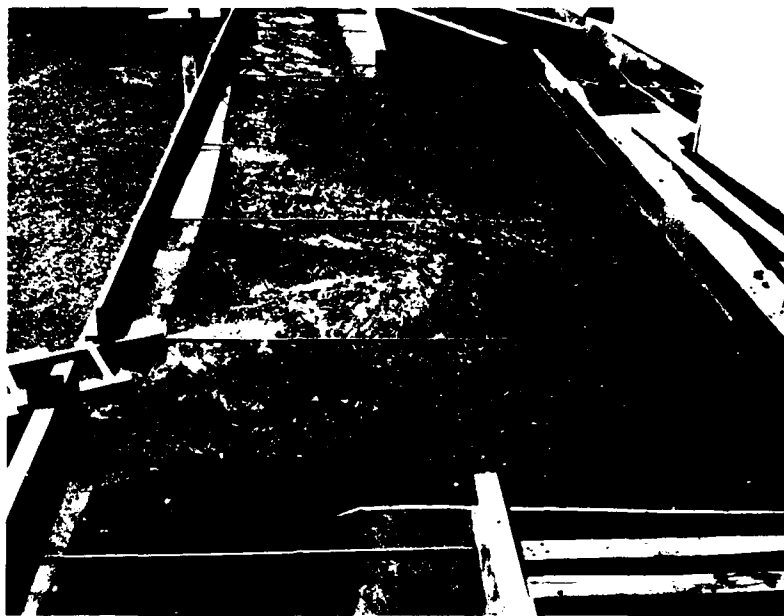
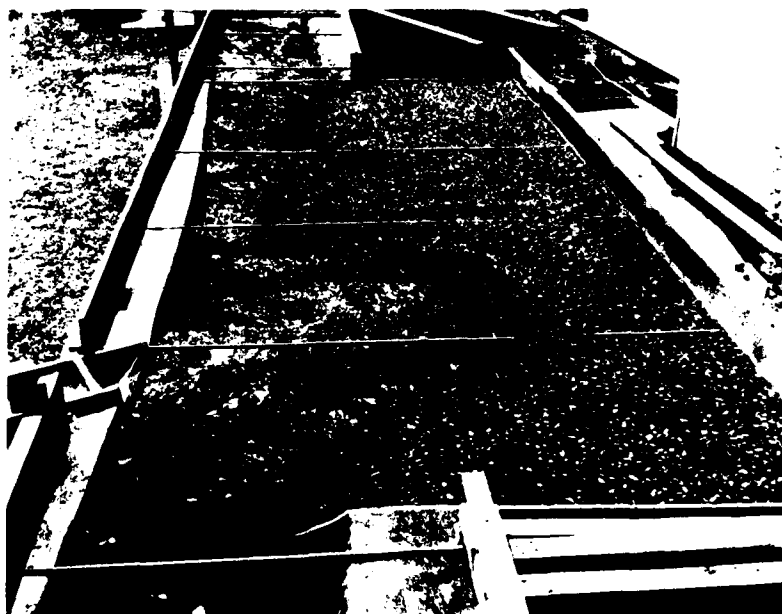
Photograph 63. Placer Creek discharge 2,500 cfs

Photograph 64. Placer Creek discharge 1,000 cfs

Views From South Fork Coeur d'Alene River

Thunderstorm Flood Hydrograph  
South Fork Coeur d'Alene River Discharge 400 cfs

34. Only drifting and readjusting of bed material occurred at a flow of 3,500 cfs during the 5th hour of the storm. After 5 hours and 30 minutes flow receded to 3,000 cfs and most of the right bank was exposed again. Some rock still moved along the river bottom as flow settled back into the main channel. Photograph 63 shows how the 2,500 cfs discharge (6th hour) flowed against the left bank (wall). The flow moved some loose material but did not scour the existing invert.

35. At 2,000 cfs, after 6 hours and 30 minutes of the storm, shooting flow from Placer Creek was further reduced. Loose rock still moved along the invert but major scouring had ceased. Flow from Placer Creek started to turn downstream within the river during the 7th hour of the storm when the discharge was 1,500 cfs. All material had stopped moving, and the riverflow was confined to the left half of the channel by the deposited material. Flow was entirely downstream with a flow of 1,000 cfs (photograph 64). Riverflow was confined to a 25-foot-wide channel on the left. Just before the test was concluded with a minimum

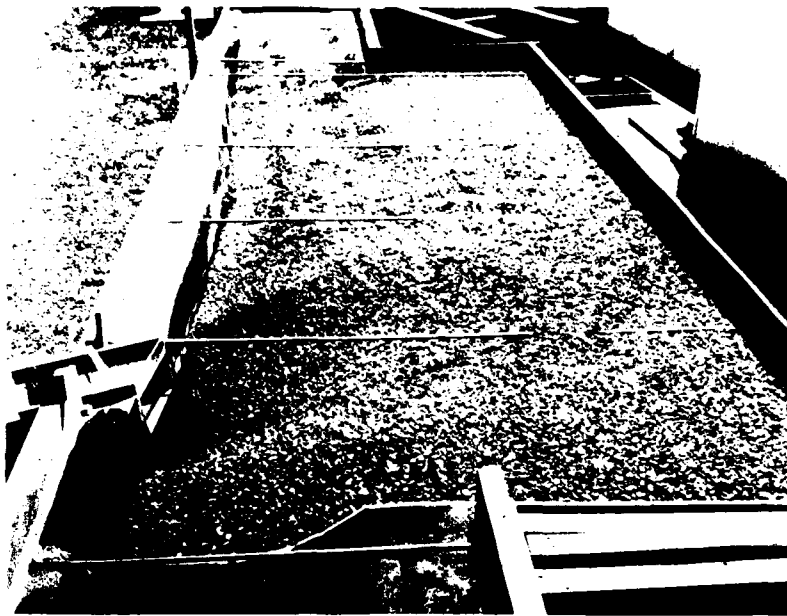
Photograph 65. View from upstream

Photograph 66. View from downstream

Thunderstorm Flood Hydrograph  
Eroded Condition at End of Flood

flow of 500 cfs (after 8 hours and 30 minutes of the storm), bed material was observed to be deposited as far as 250 feet downstream from the movable bed section. Scour and deposition at the end of the flood are shown on plate 15 and in photographs 65 and 66. Flow through the highway culvert at the mouth of Placer Creek was open-channel flow at all times during the 200-year thunderstorm design flood.

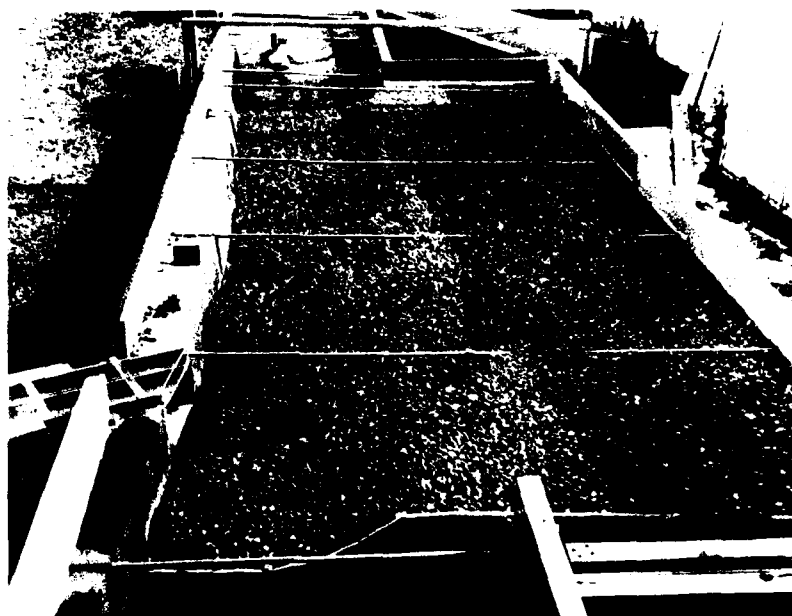
Photograph 67. Movable-bed section of South Fork  
Coeur d'Alene River

Eroded Condition at End of Winter Rainflood  
Hydrograph Following a Thunderstorm Flood Hydrograph

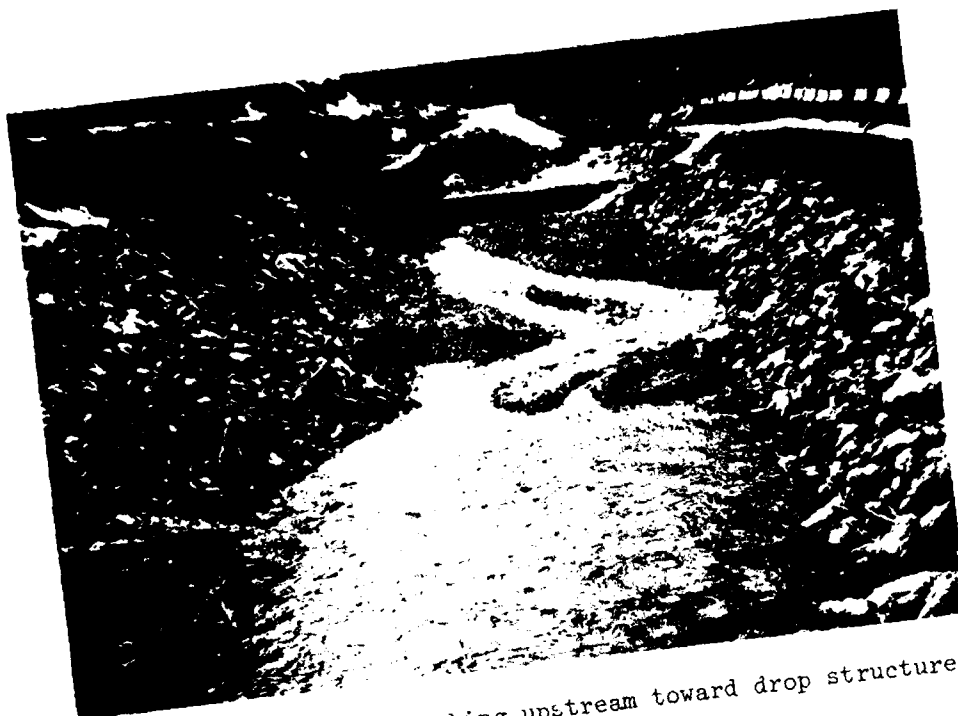
Photograph 68. View looking upstream toward drop structure

Photograph 69. Upstream face of trash barrier

Prototype Debris Basin Following February 1982 Flood
